CHESAPEAKE BAY SHORELINE STUDY - INTERIM REPORT

C.S. Hardaway
G.R. Thomas
J.-H. Li

Virginia Institute of Marine Science
College of William and Mary
Gloucester Point, Virginia 23062

December 1989

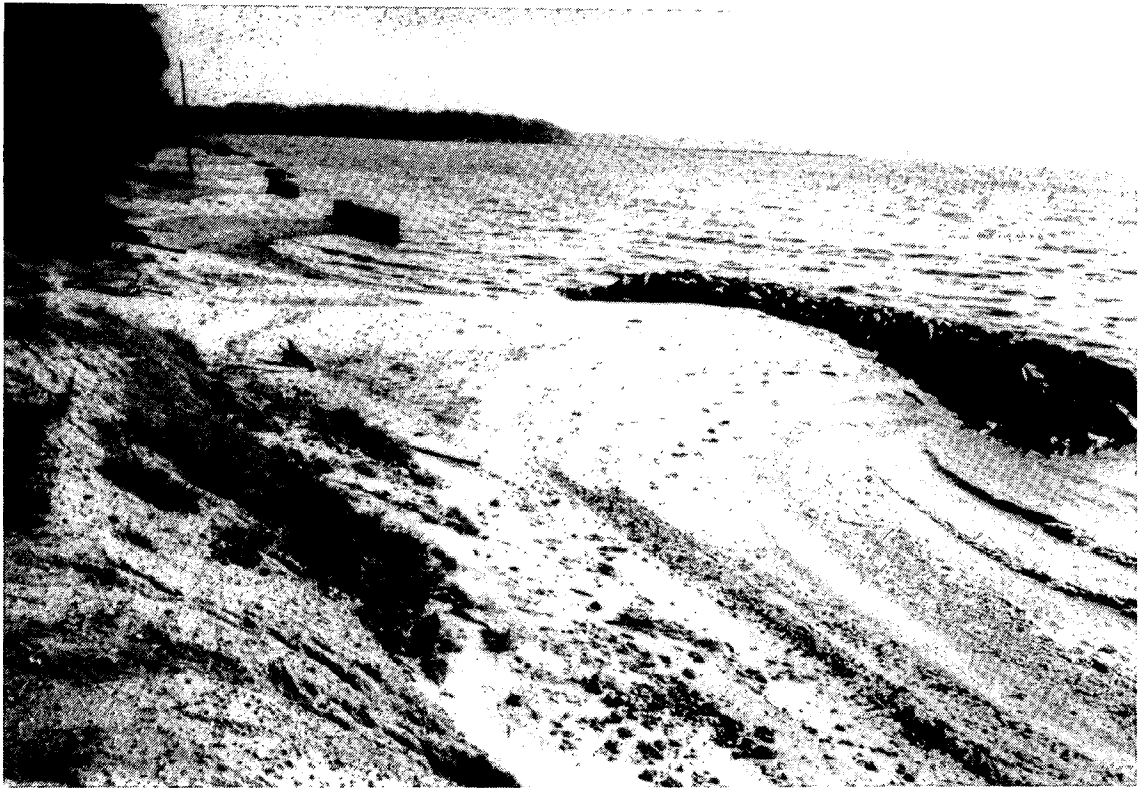
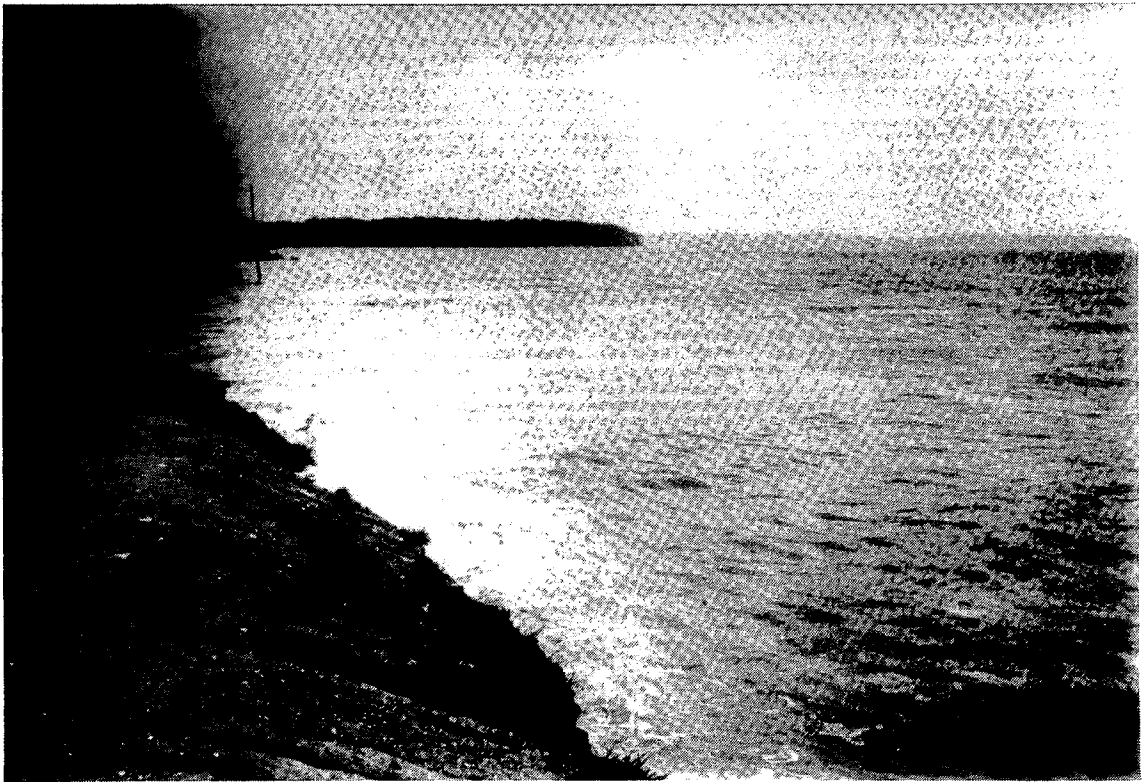
Figure 27A. Hog Island Breakwaters - ground view, looking south.
April 15, 1988, post-storm.

Figure 27B. Hog Island Breakwaters - ground view, looking south.
April 13, 1988, during northeaster. Use telephone
pole along shore for reference.
